Use of test and removal strategy to contain an ASFV outbreak in a farm

Jiancong Yao¹, Zhigang Liang², Qing Yang¹, Congmin Liu¹, Tian Xia¹, Marisa Rotolo¹, and Dan Tucker³ ¹PIC, miles.yao@genusplc.com, ²New Hope Liuhe, ³University of Cambridge

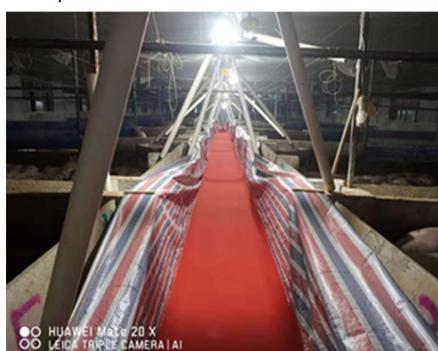
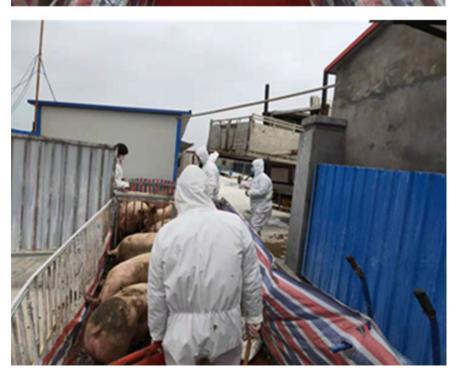
On DPA 14 the 6 ASFV PCR positive pigs were humanely euthanized (electrocution), placed in impermeable plastic bags and moved out of the farm for incineration. The barn hallway was sealed with impermeable plastics to avoid dissemination of potentially contaminated organic material to other pens. Then the left half of barn #1 (pens 1-6) was depopulated. After partially depopulating this barn, empty pens and hallways were covered with caustic soda, and

Fig 1. The use of plastic canvas to create separations and remove pigs from barn #1

disinfected with formaldehyde. During this process farm employees were not allowed to enter the positive barn and internal and external biosecurity was strictly reviewed and implemented to prevent further contamination. Oral fluids continued to be collected every 3 days throughout the
